Manhole Inspection Summary

Manhole # S13KK1022MH

Insp Date: **1/17/07 11:19 AM**

Location Address: **3000 WYLIE AVE**

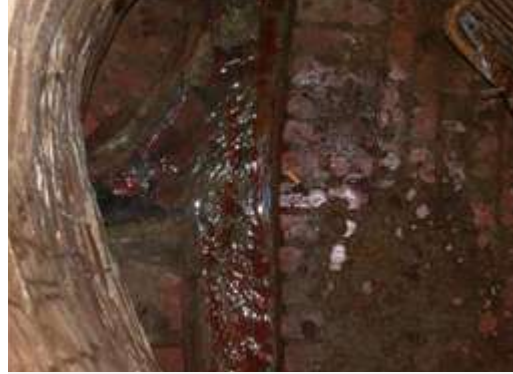
Top View

☒ **Debris** (not Condition related)

☒ **Corroded**

☒ **Evidence Of Surcharge**

Evidence of surcharge - Bench debris.
Corroded steps.

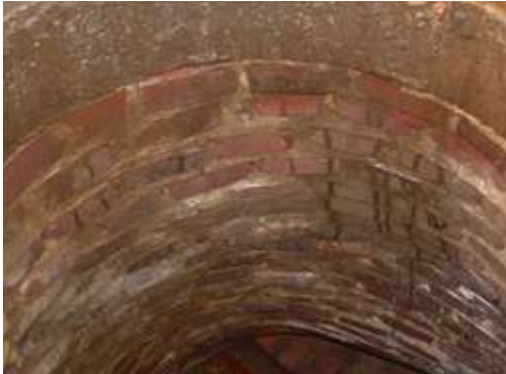
Defect

☒ **Leaks**

Infiltration: ☐ None ☒ **Joint** ☐ Cracks ☒ **Mortar** ☐ Roots ☐ Wall

Infiltration: ☐ None ☐ Joint ☐ Cracks ☒ **Mortar** ☐ Roots ☒ **Wall**

Frame leaks. Adjustment and Barrel
infiltration.

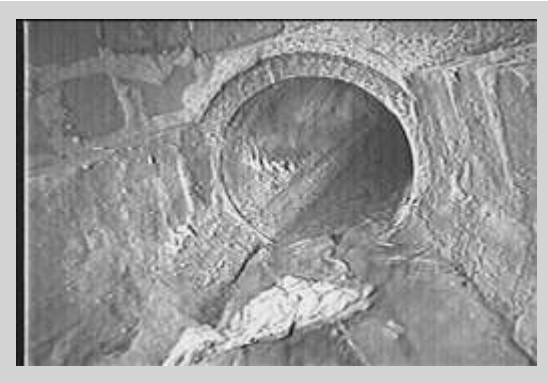
8 in. Circular Gravity Sewer Pipe Out @ 12 O'Clock

Channel deterioration.

Deposits: ☐ None ☐ Mud ☐ Sludge ☐ Debris ☒ Grease

Infiltration: **Evidence** Pipe Seal Cond: **Unknown**

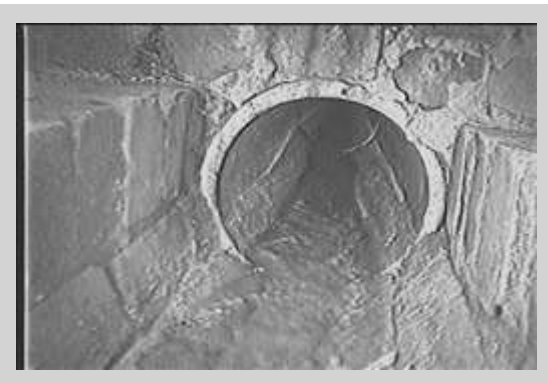
8 in. Circular Gravity Sewer Pipe In @ 6 O'Clock

Deposits: ☐ None ☐ Mud ☐ Sludge ☐ Debris ☒ Grease

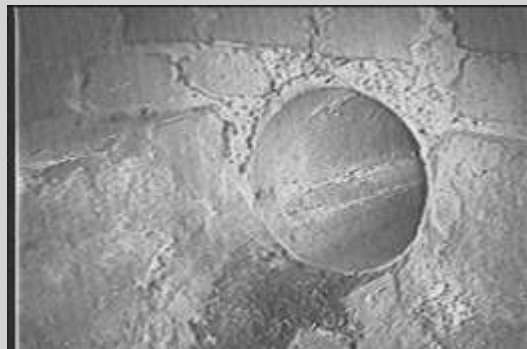
Pipe In @ 8 O'Clock

Pipe Seal Cond: **Cracked**
